Coating conditions in water ballast tank, void space and cargo oil tank of aged ships and required performance standard of protective coatings for new ships

Takanobu Murakami (SKDY)
Takayuki Sasaki (IHIMU)
Masahiro Kuwajima (MES)
Masanobu Koori (MHI)

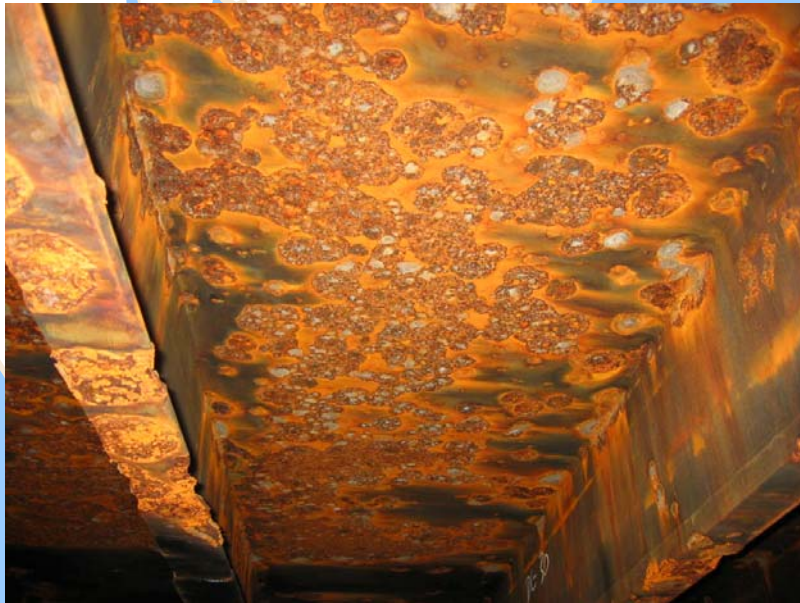
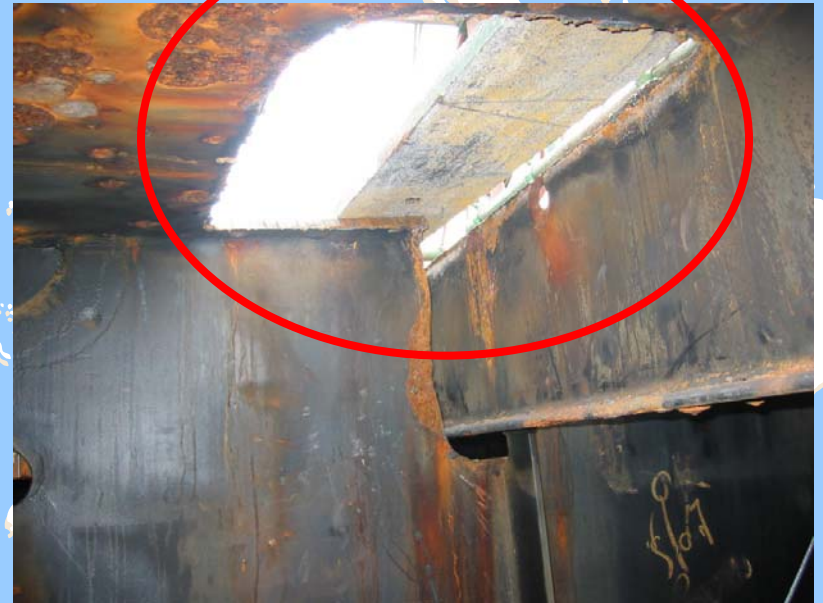
3-2-2. Overview in the water ballast tanks (Ship A)

Deck head area under upper deck seems to be in quite severe environment condition.

Rust is initiated from edges and welds, and good treatment on edges and welds will prevent rust initiated.

Apparently, coating specifications of the ships for water ballast tanks at new building don't satisfy 15 years coating life.

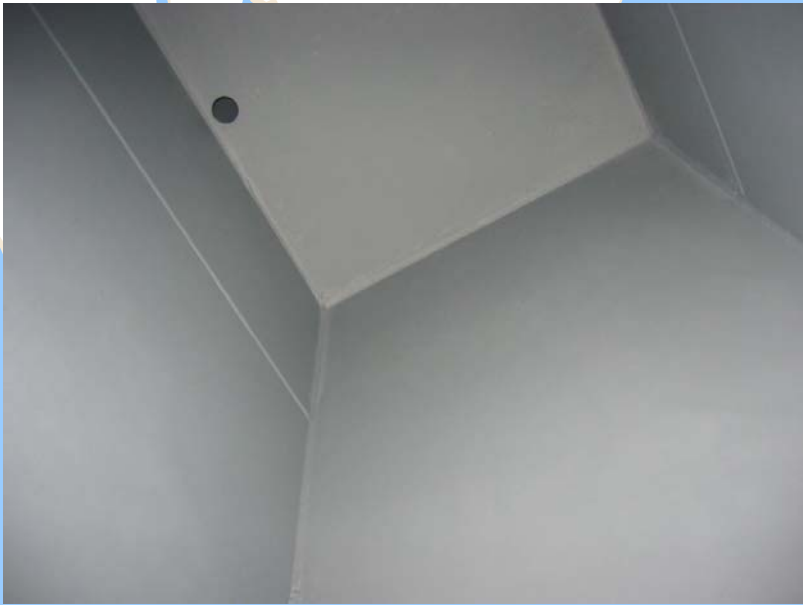
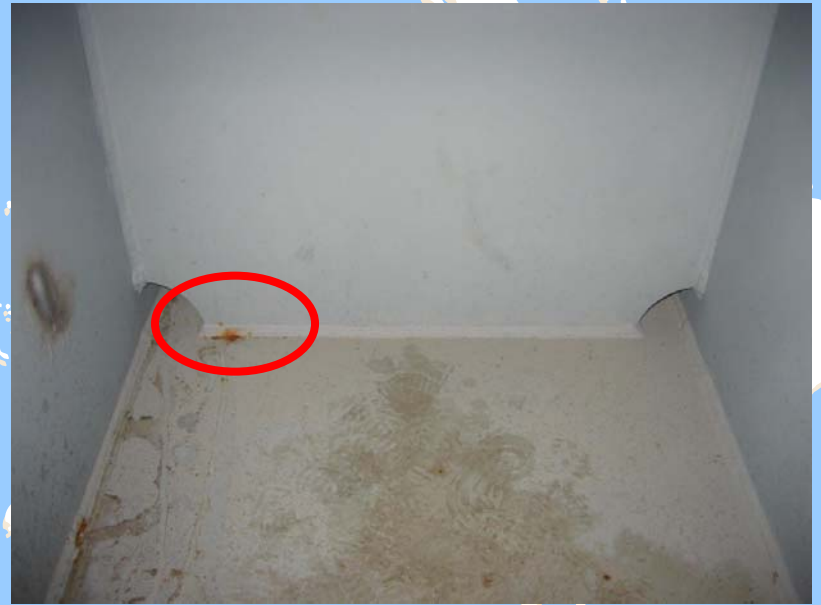
3-3-2. Overview in the void spaces (Ship A)

Although all inspected ships had been in use for 10 to 15 years, coating in void spaces were still almost perfect condition.

Very small local corrosions were observed in the areas prone to be damaged mechanically. These areas estimated smaller than 0.1% of the total area.

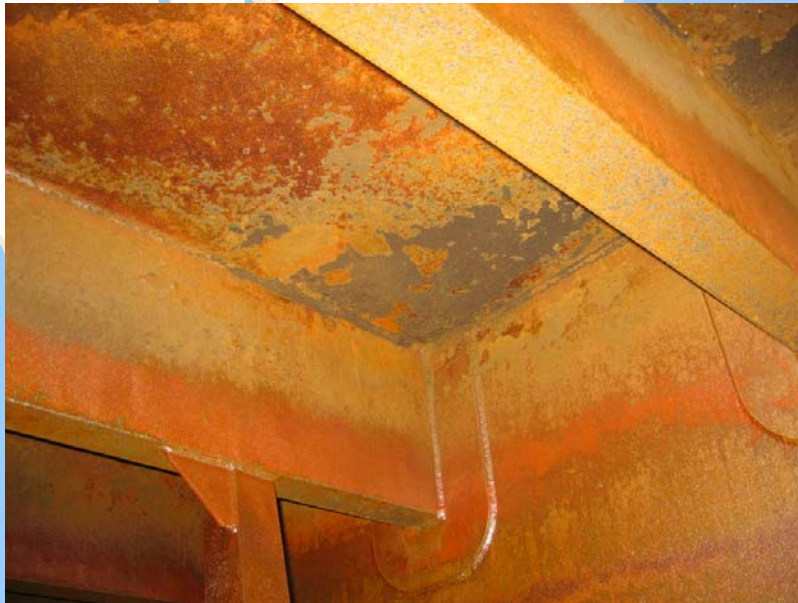
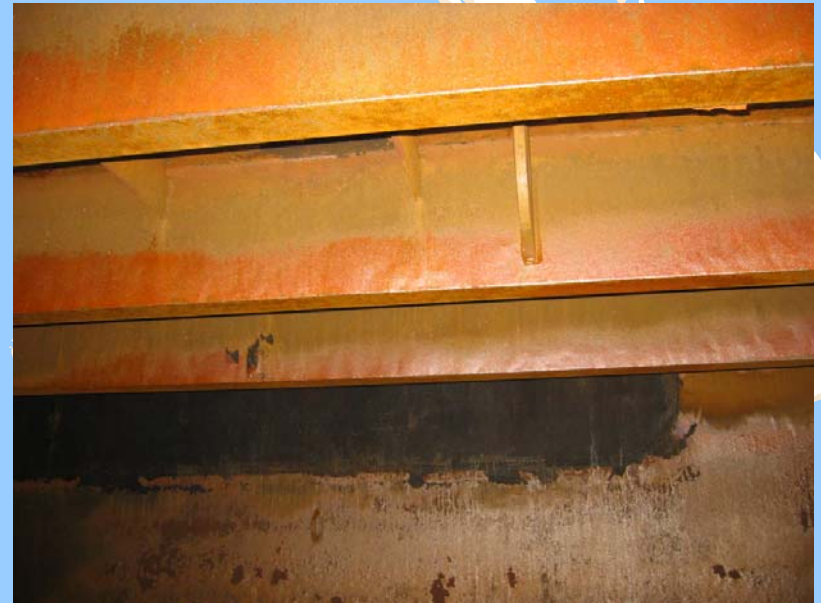
3-4-2. Overview in the slop tanks (Ship A)

Coatings in the cargo tanks were comparatively in better condition than those in water ballast tanks.

Though some corrossions were observed in deck head areas, plate loss was quite small, while re-coating or plate renewal was necessary for some of deck head areas in water ballast tanks of the same ship.
