Corrosion-Resistant Steel for COT of Crude Oil Tankers

ASEF 2007, Tokyo, JAPAN

Shin IMAI

Japan Ship Technology Research Association

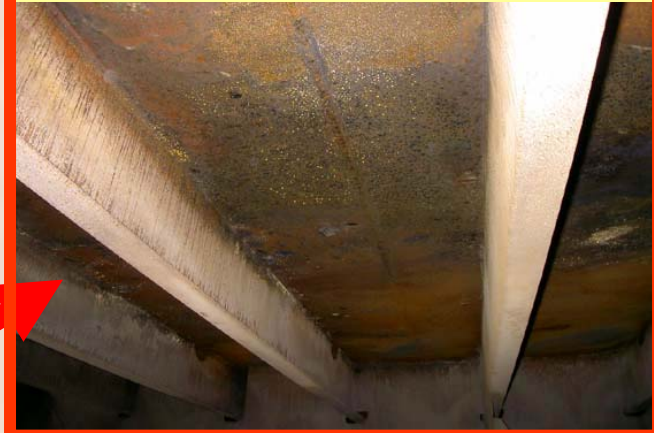
Upper Deck
 \Rightarrow General Corrosion

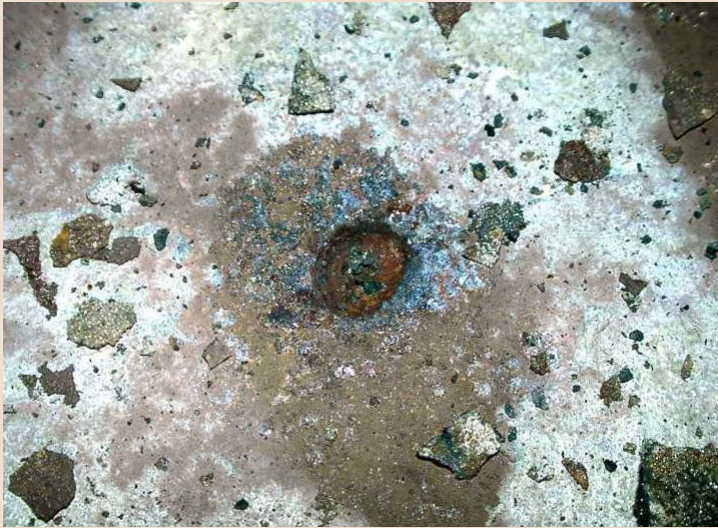
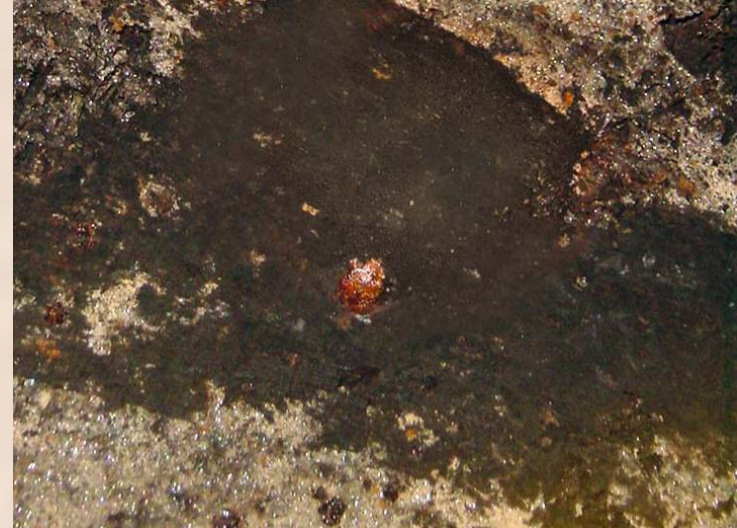
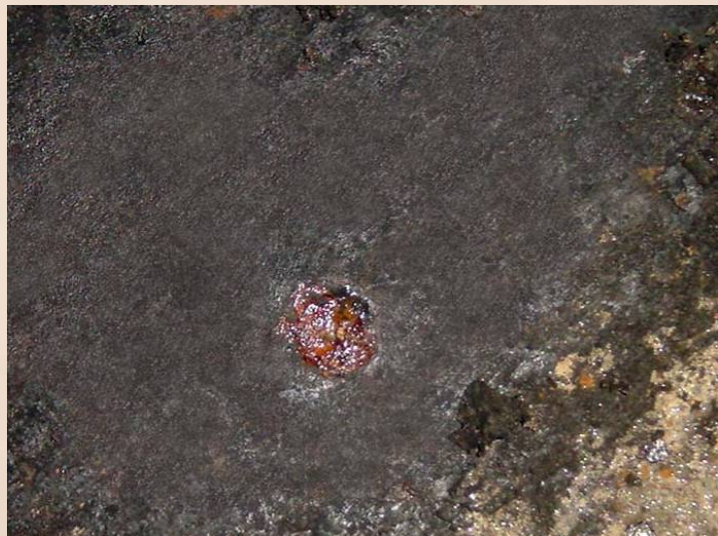
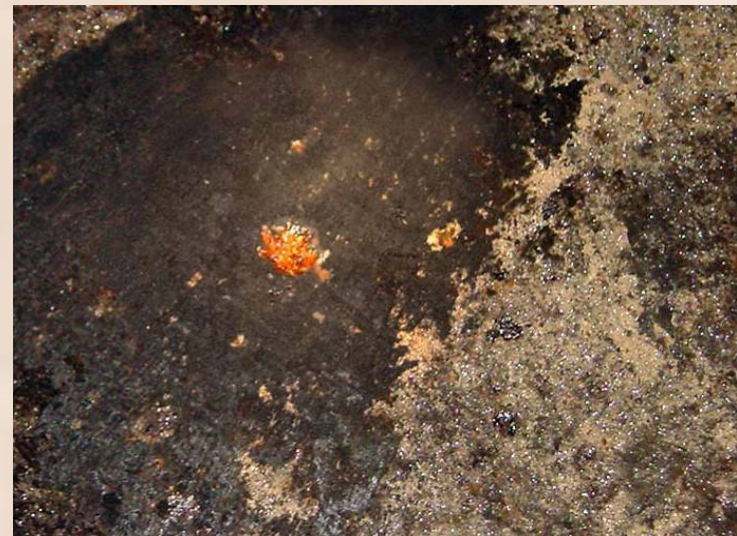
Oil-coating exists around pit ...

.... and pitting starts at oil-coating defect

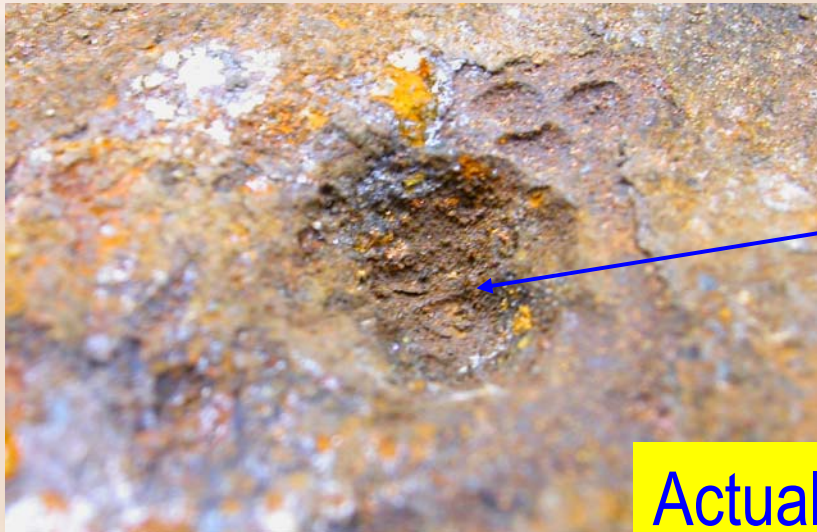
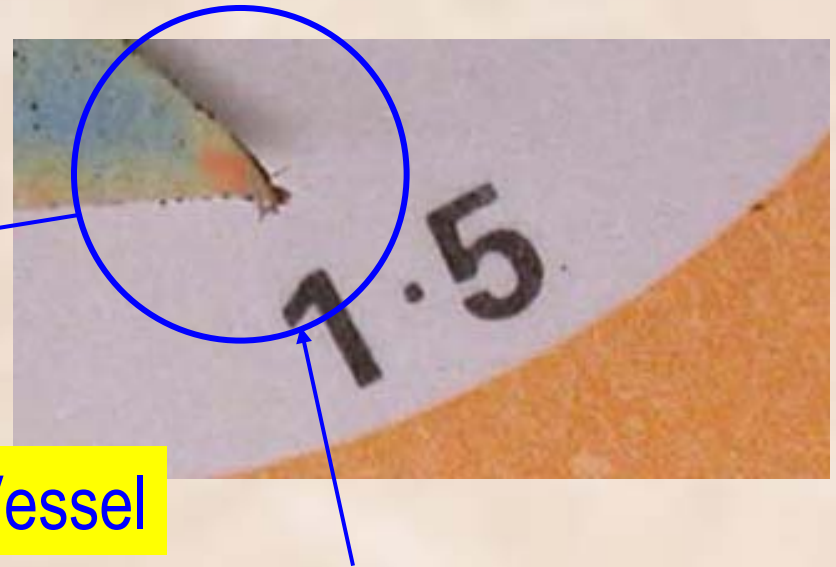
Strong Acid environment

Actual Vessel

pH of PIT inside: <1.5

→ **Unfavorable for MIC** (SRB active pH : 6~9)

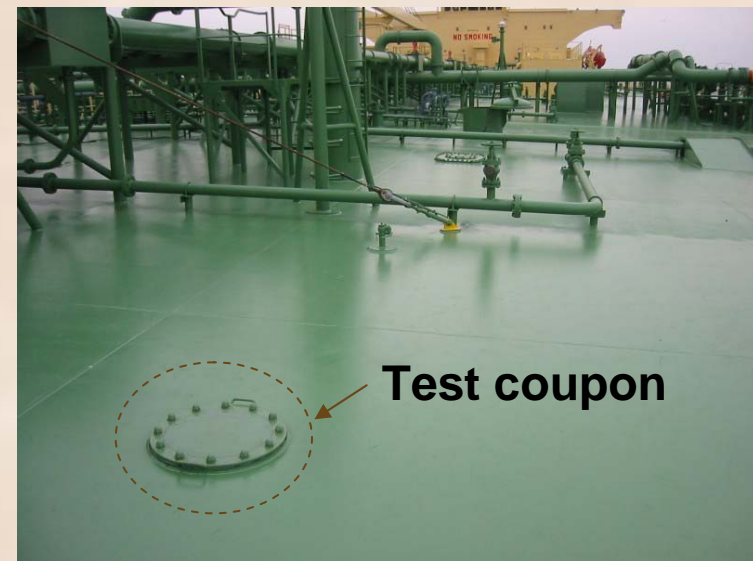
An example of on board test of upper deck

Test coupons were exposed in vapor space of COTs of 2 aframax tankers for 1 year

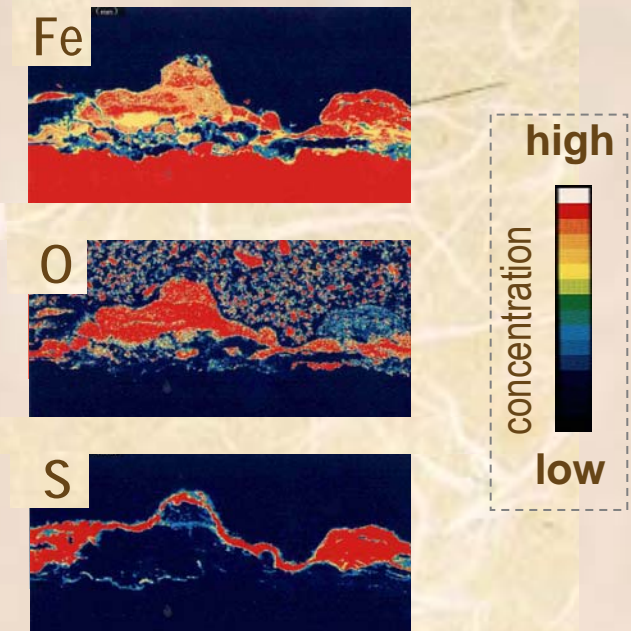
Cross sectional analysis of corrosion product formed on conventional steel after test in reproduced corrosion environment in laboratory.

Distribution of elements

Laboratory corrosion test reproduces corrosion phenomena at upper deck of actual COTs.

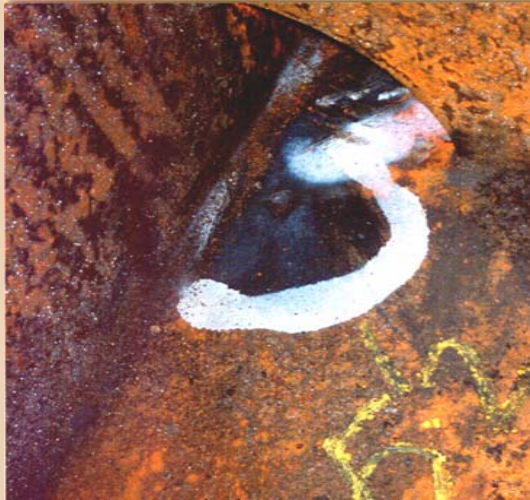
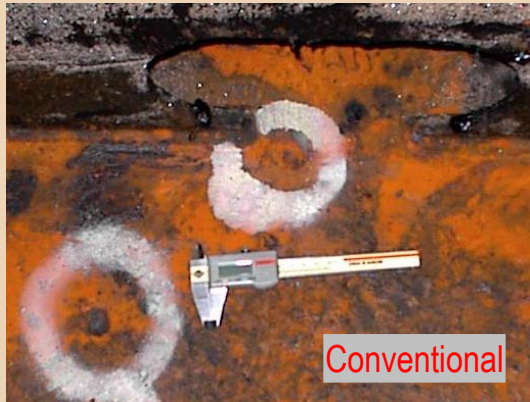
Conventional steel

Frequent deep Pits

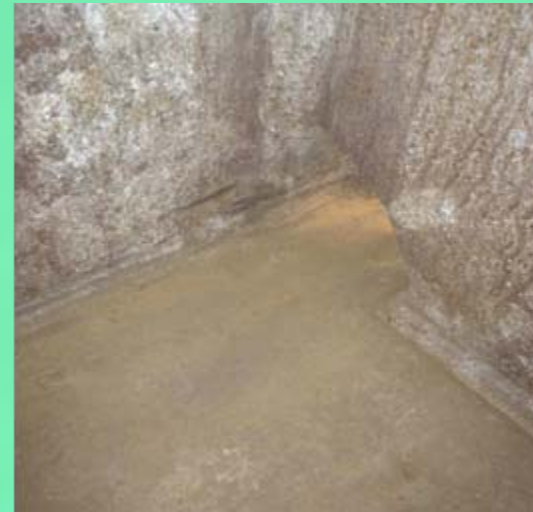
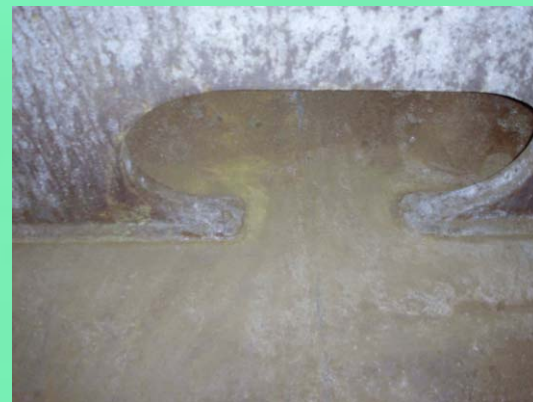
Corrosion Resistant Steel

No Pit observed

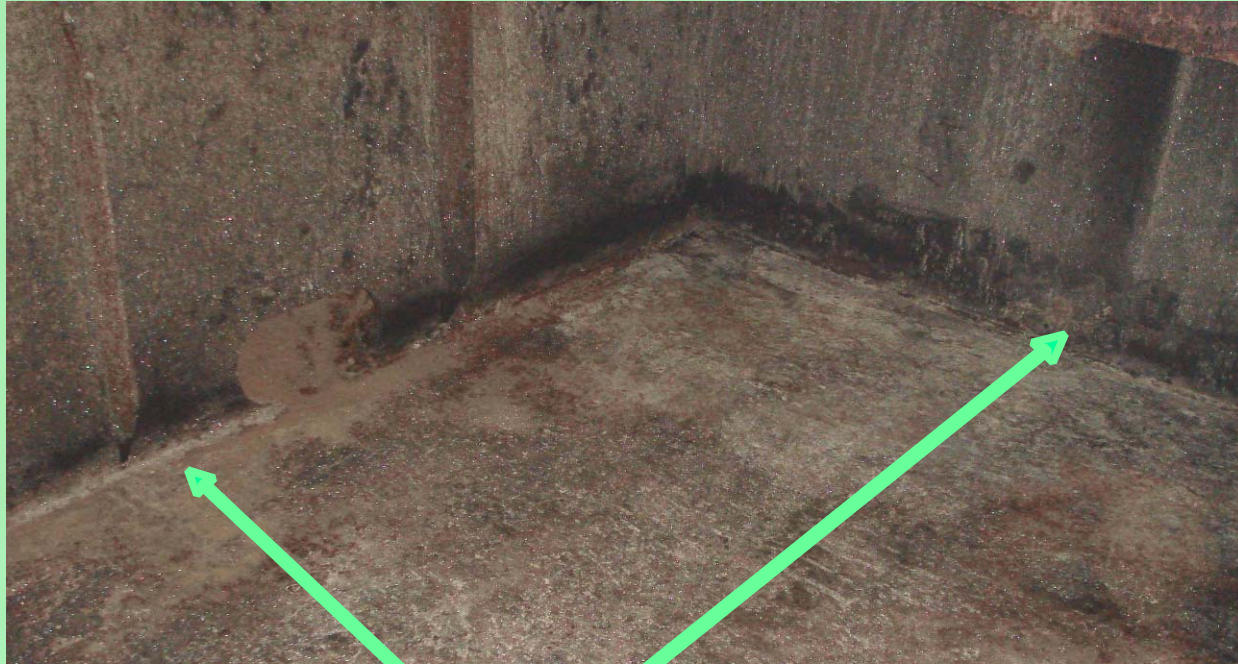
Corrosion Resistant Steel

No Pit around Weld

No pit has been observed also on conventional steel
